Service Bulletin 28

(a) Service Bulletin No:	28
(b) Revision / Date	2 / 04-March-2020
(c) Title:	Stratus Double Burner, Burner Hanger Inspection
(d) Description:	Inspection / Replacement of Stratus Double Burner Hanger.

SB28: Accomplishment Instructions.
Stratus Double Burner; Mounting Hanger Inspection.

CBL/TN/DCB/3191

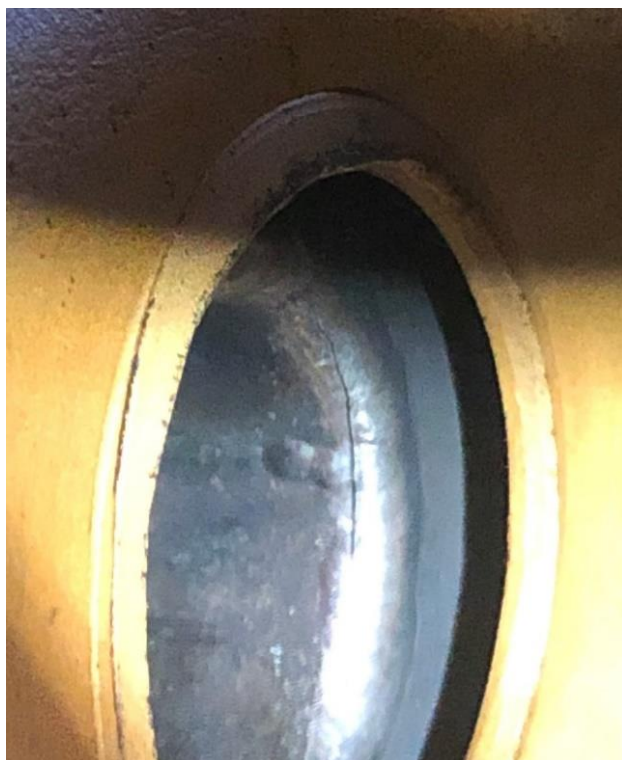
The failures appear to be caused by progressive fatigue cracking of the welded joint between the central tube and the end plate of the hanger assembly

Fig 1. Hanger with Weld Crack.

3/ Should any visible cracks be found further flight with the affected burner is not permitted. Report any observed defects to technical@cameronballoons.co.uk attaching photographs if available. **Cracked hangers must not be re-welded.** Repair affected burners by replacing the cracked hanger with a new issue D or later burner hanger.

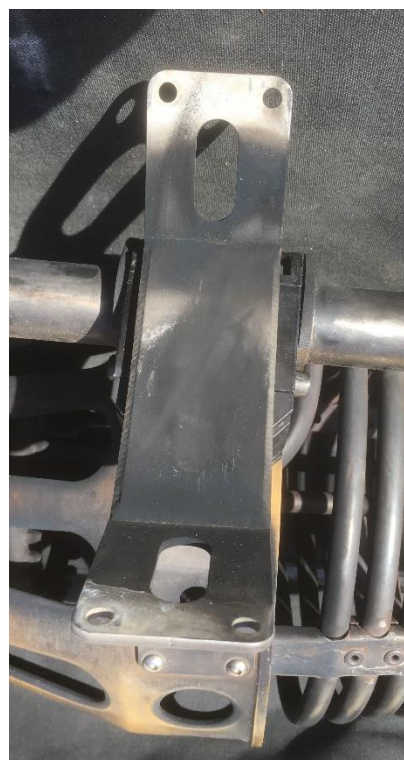
6/ A number of burners were produced in 1995 / 1996 using a doubler plate to reinforce the central part of the hanger bracket (Fig 2). The welded joint is hidden by the doubler plate and therefore impossible to inspect. Hangers of this design must be replaced by a new hanger CB8504-0000 Issue D or later.

Fig 2. Hanger with doubler plate.

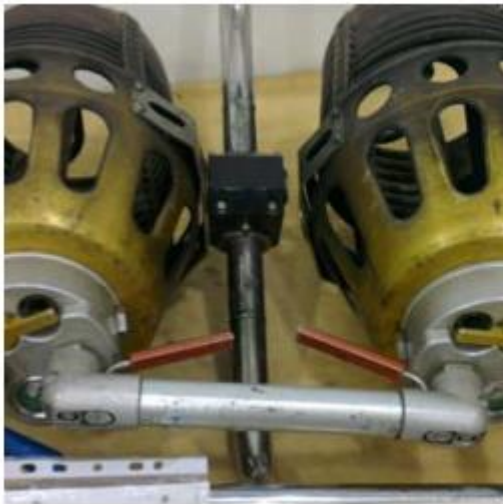
- 1.1.1 A Stratus Burner hanger CB8504 has failed in service after landing. The burner hanger failed, leaving one burner unit detached from the load frame. The burner was supplied in April 1999 and its history is unknown.
- 1.1.2 Investigation of the Cameron Balloons Problem Report System revealed a small number of similar failures; SB28 is issued as a result.
- 1.1.3 This document provides the accomplishment instructions for SB28.
- 1.1.4 Throughout this document all Maintenance Manual references are to Issue 10 Amendment 4 or higher.
- 1.1.5 The design of the welded hanger assembly was fundamentally revised at Issue D (2009). Only Issue A, B & C components are affected.

Fig 1. Double Stratus Burner Unit
Note failed hanger on the right.

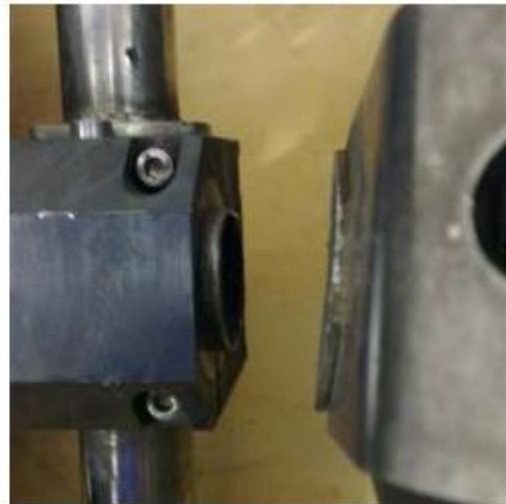
Fig 2. Close-up of weld failure.

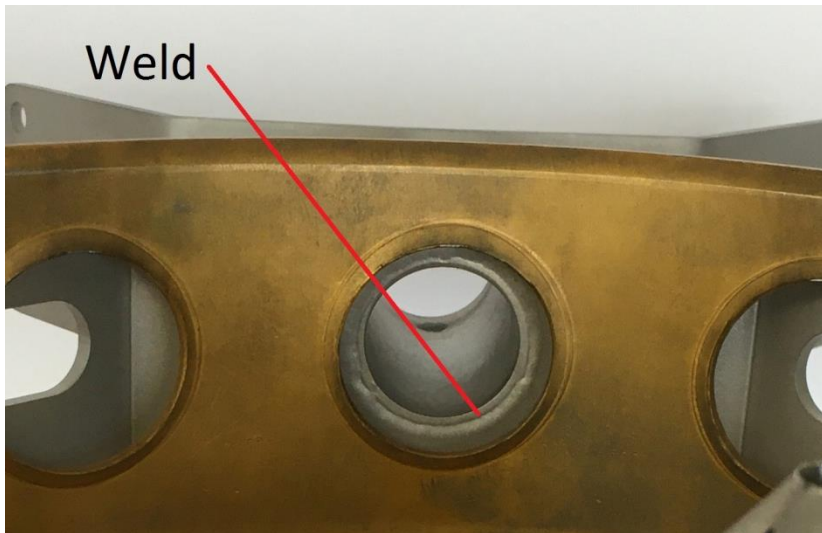
Fig 6. View of the affected weld. Note burner coil removed for clarity.

- 3.1.1 The weld in the end of the hanger can be seen through the holes in the can. A torch and a mirror may be required to give a clear view.
- 3.1.2 Remove any soot or dirt prior to inspection. WD40 or kerosene (paraffin) is the preferred cleaner; some solvent cleaners may damage the finish of the can.
- 3.1.3 Inspect the weld for any signs of cracking. Attempting to move the burner relative to the hanger may assist in making the crack visible.
- 3.1.4 If a clear view cannot be obtained or there is any doubt then the hanger must be removed from the burner. The burner is mounted to the hanger with M5 fasteners CY-0005-1004, CY-0005-1016, and CY-0005-2009. A single M3 screw secures each burner manifold block to the tubular handle.
- 3.1.5 Cracked hangers must be replaced before further flight with a new part CB-8504-0000 Issue D or later. **Cracked hangers must not be re-welded.**
