Service Bulletin 28

(a) Service Bulletin No:	28
(b) Revision / Date	2 / 04-March-2020
(c) Title:	Stratus Double Burner, Burner Hanger Inspection
(d) Description:	Inspection / Replacement of Stratus Double Burner Hanger.

SB28: Accomplishment Instructions.
Stratus Double Burner; Mounting Hanger Inspection.

CBL/TN/DCB/3191

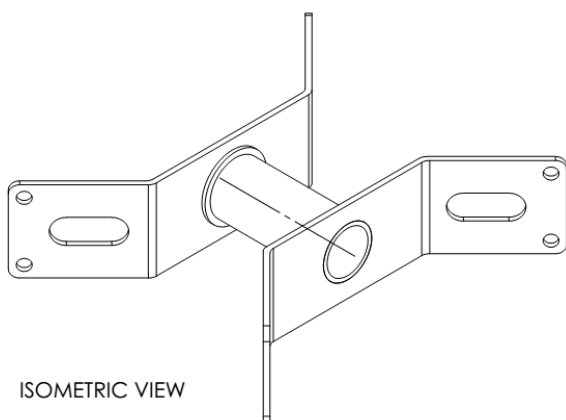
Fig 4. View of Hanger Assembly.

2.1.2 Affected hangers (Issues A through C) have either no machine engraving or have “Cameron Balloons Limited” machine engraved in the upper right-hand corner of the end plate. Non-affected hangers (Issue D and E) have the text “Cameron Balloons Limited” machine engraved in the lower right-hand corner of the end plate.
